SUBJECT: NWW-2004-0600046, Suspension Letter for authorization under NWP 14  
Site 1, US-95 Thorn Creek Road to Moscow, ITD Key No. 09294

## MEMORANDUM FOR RECORD

NWW-Regulatory Division NWW-2004-0600046, US-95 Thorn Creek Road to Moscow

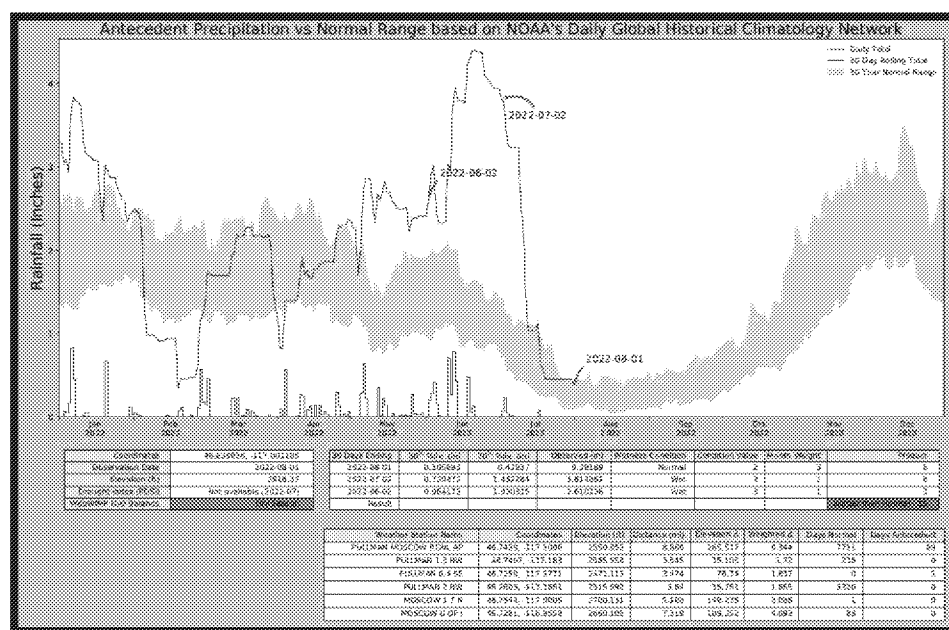
The Antecedent Precipitation Tool (APT) confirmed that the Corps' field verification visit occurred within the 30-year normal range for precipitation in the region and that the verification occurred during the dry season, see figure 1 below. Previous precipitation events in June and July 2022 exceeded the 30-year normal range for precipitation, which is why the APT identified the precipitation conditions as wetter than normal for the August 1, 2022, site visit. No precipitation was observed on site during the Corps' site visit. The most recent precipitation event occurred on July 17, 2022, for the weather stations utilized by the APT.

Figure 1, Antecedent Precipitation Tool Results for August 1, 2022, Field Verification at Site 1 of the US-95 Thorn Creek to Moscow highway improvement.

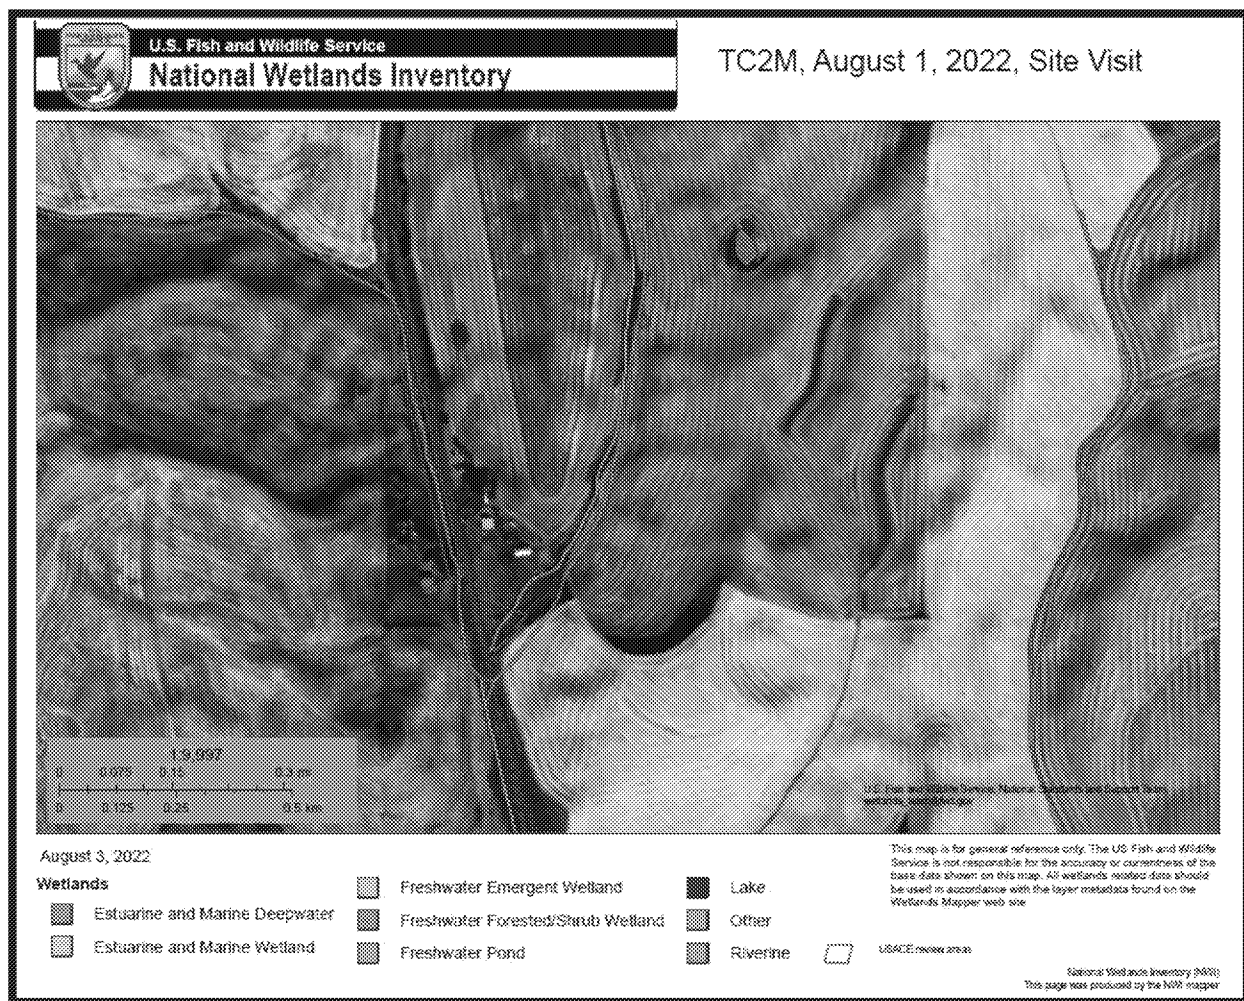
The review area for wetland WLN is not rated as a wetland based on the USFWS wetland mapper, dated August 3, 2022. Wetland WLN2 is also not demarcated on the USFWS mapper; however, a thin tributary-related wetland is identified.

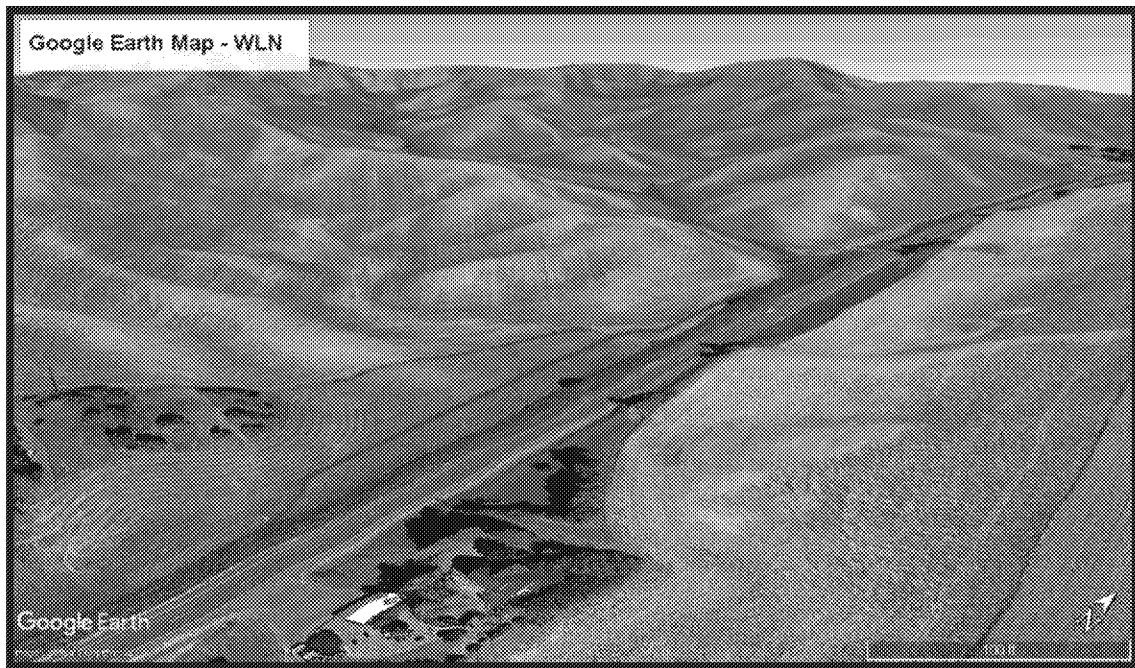
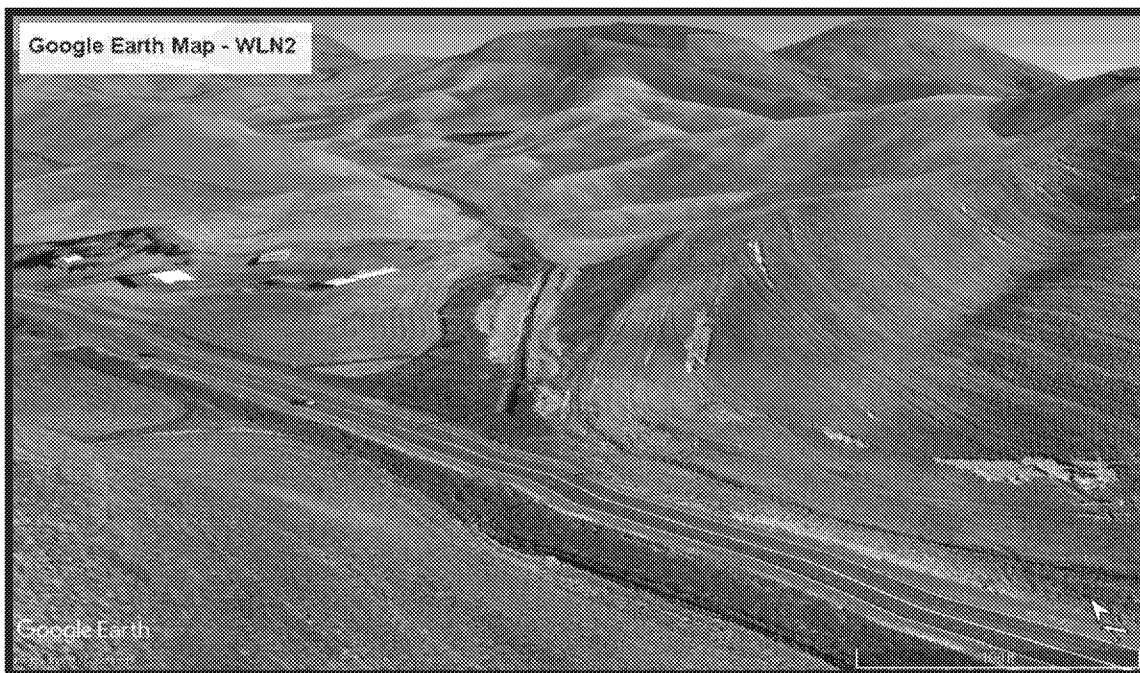
Wetland "WLN" is located within the valley bottom near the western side of US-95. Wetland "WLN2" is located within the valley bottom near the eastern side of US-95. Wetlands WLN and WLN2 are found near the toe of slope of the agricultural hillsides. Both wetlands are in close proximity to agricultural practices such as haying of grass fields. The evaluation of samples DP13W and DP14W occurred in a small patch of undisturbed vegetation surrounded by hayed field. However, the need for a smaller assessment area (5ft radius) for herbaceous strata was sufficient for the samples. The other pits were located within relatively undisturbed vegetative strata. WLN parallels tributary P and the hillslope leading to tributary P.

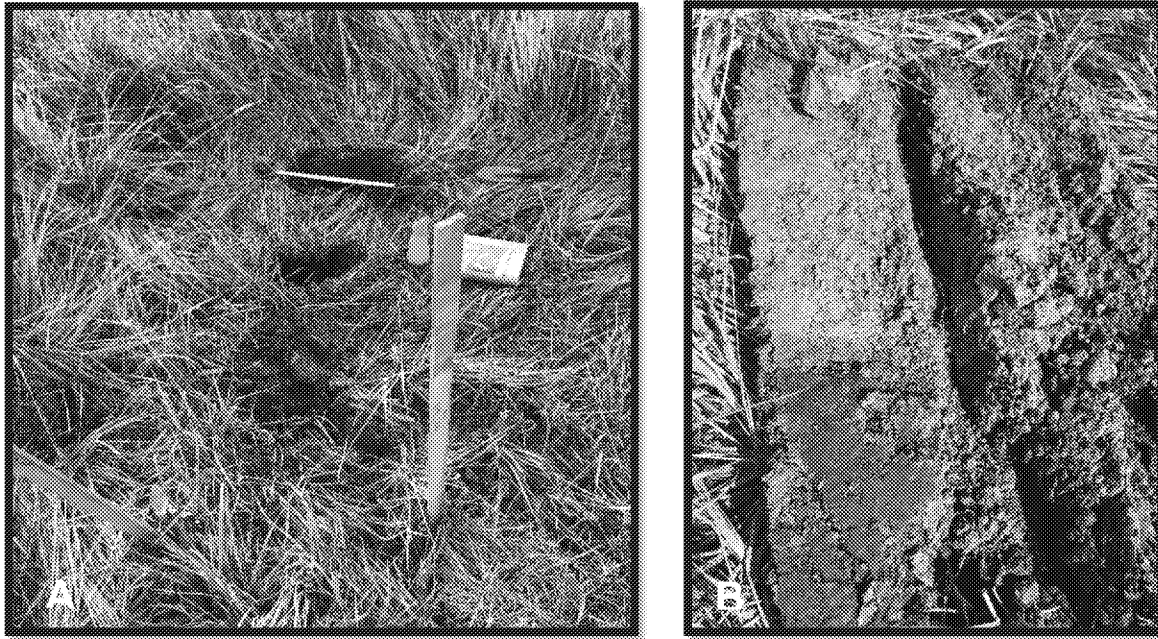
At each of the five previously established data points the Corps collected soil cores for soils evaluation from new soil pits dug within a 3-4 feet radius of the two existing (PRDC's and ITD's) wetland delineation pits, see Figure 3A below. A sharpshooter shovel was used to collect an approximately 6-inches wide by 6-inches long by 15-inches deep soil core sample used in the evaluation. This larger than typical soil sample allowed the Corps to bisect the sample with a soil knife into two samples approximately 3-inches wide by 6-inches long by 15-inches deep, which allowed one side to remain dry to reference any redox features that might be harder to identify. One side of the sample was opened to ensure no instrument contamination from the shovels or knife impacted the soils which were being evaluated, see Figure 3B below.

Figure 3A – Corps Sample Pit location in relation to ITD Sample Pit (Right-hand Stake) and PRDC Sample Pit (Left-hand Stake).  
 Figure 3B - Photo of a bisected Corps soil core (sample on right-hand side was broken open and evaluated).

For soils matrices with a darker color, the soil core was allowed to dry for 20-40 minutes to allow for the redox features to become readily visible, pursuant to the F6 indicator user notes of the Arid West Regional Supplement<sup>1</sup>. After soils dried, the samples were then moistened until the color no longer changed. The wetted soils were then allowed to dry until they no longer glistened. The soils evaluation was then conducted.

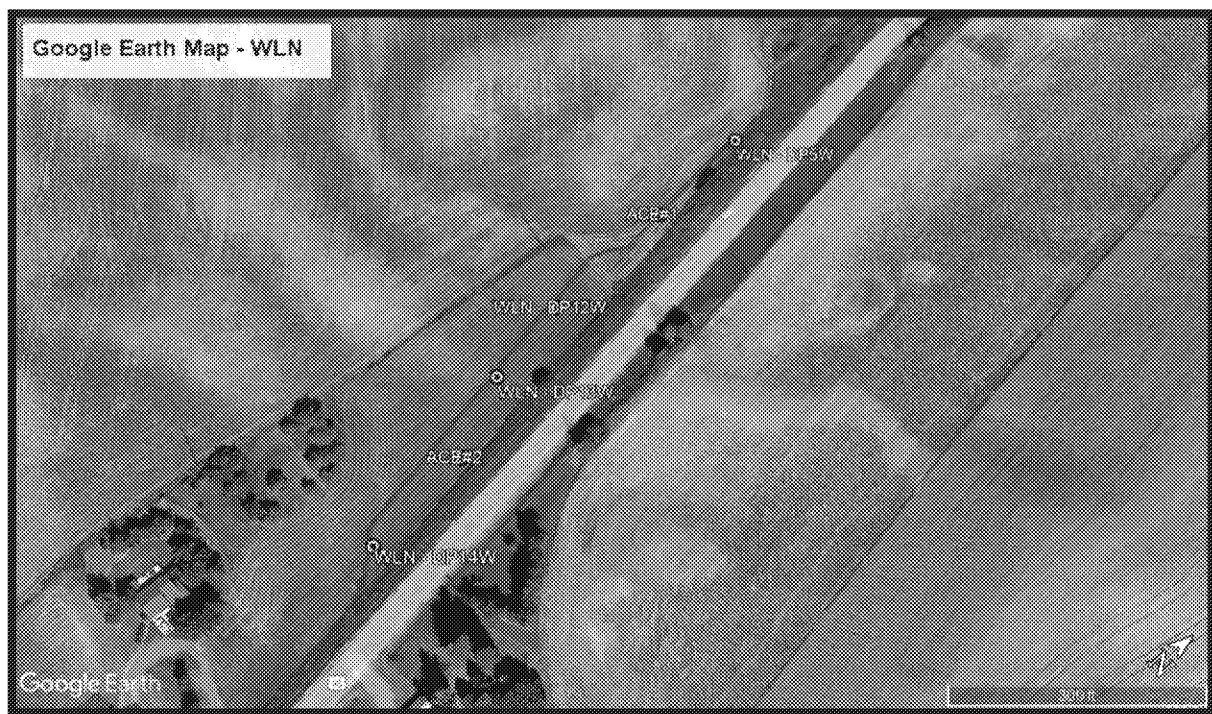
## 2.8 Wetland WLN2.

The Corps evaluated one wetland data pit (DP2) for the wetland identified as “WLN2” in the PRDC report dated June 29, 2022. The sample point DP2 met all three wetland parameters during the Corps evaluation.

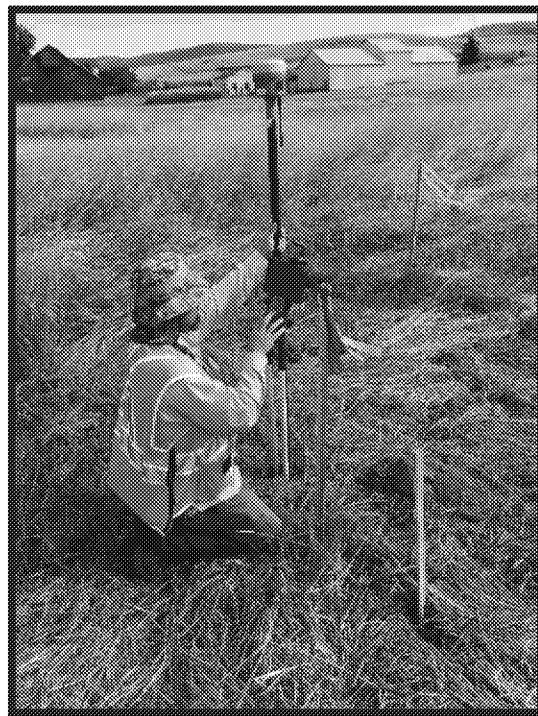
The geospatial coordinates for the Corps' wetland soil pits/data points were collected by a Corps staff surveyor (Robert J. Byrons) using a Trimble R12i base with Rover GPS, on August 2, 2022, see Figure 4 below. This GPS unit has horizontal accuracy of approximately 8 millimeters. The latitude and longitudinal coordinates for the sample points were provided on August 3, 2022, to the Corps Regulatory team.

The Corps used a Trimble R12i to record the locations of its soil pits/data points to eliminate any dispute based on the GPS device used. However, use of the Trimble R12i was not necessary. The location of the points evaluated by the Corps and their proximity to the points evaluated by PRDC and ITD were not in question. Moreover, the points evaluated by PRDC and ITD, and affirmed by the Corps on August 1-2, 2022, were all flagged and readily identifiable on the ground.

Figure 4 – Geospatial data collection using Trimble unit to collect Sample Point “DP2-Corps Review” within wetland “WLN2”.
